# SERVICE BULLETIN

### LANDING GEAR - EMERGENCY EXTENSION - INSPECT/REPLACE AIR LINE

**EFFECTIVITY:** Piper, Model PA-31T2, Cheyenne II XL, S/N 31T-8166001 thru 31T-8166062, equipped with Parker Hannifin P/N 199-111, Wheel and Brake Conversion Kit.

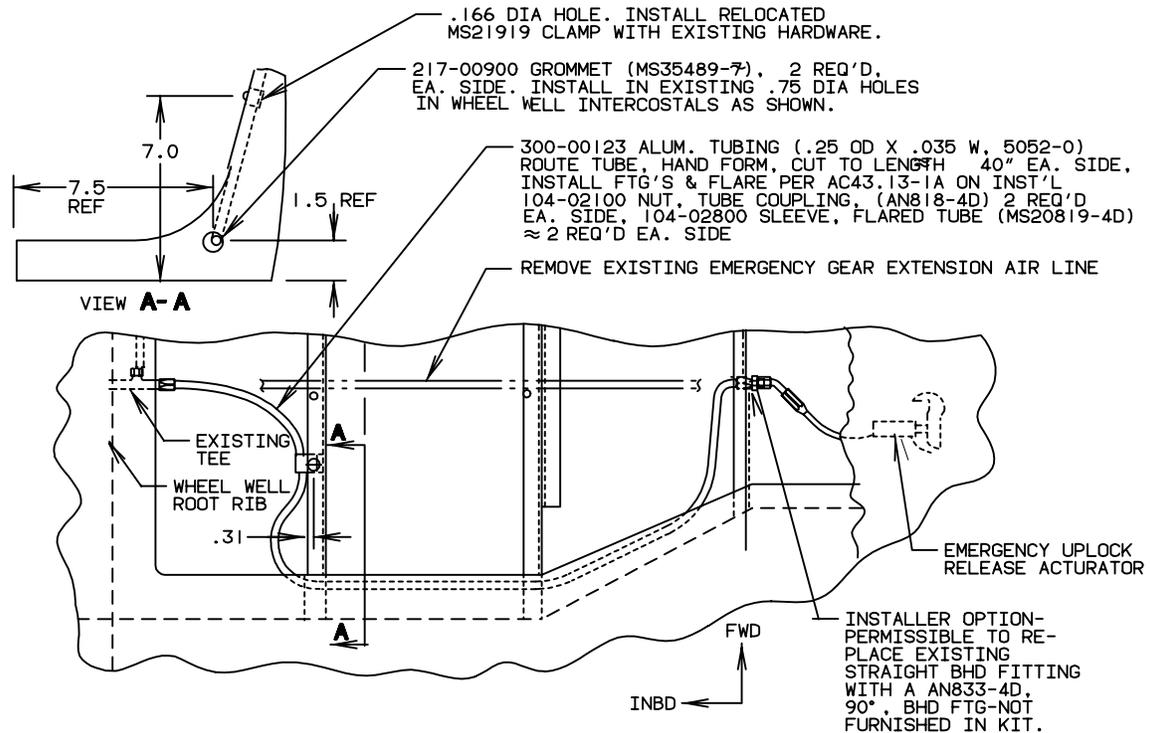
**REASON:** Improved Reliability - the combined effects of landing gear rigging, brake lining wear and routing of the emergency gear extension air line can allow the brake cylinder to chafe against the air line when gear is in the up and locked position. Continuous chafing may result in damage to the air line.

VIEW LOOKING UP-LT MAIN LDG GEAR WHEEL WELL-SHOWN, OPP FOR RT.

1. Review log books and inspect main wheel area to determine if a modification to re-route the emergency extension air line (Ref. Fig. 1) has already been accomplished. If not, proceed as follows.
2. Jack aircraft per the aircraft maintenance manual.
3. Disable emergency extension system per the aircraft maintenance manual.
4. Remove existing emergency extension air line (aluminum tubing) between the tee, outboard of the wheel well root rib and the emergency uplock release actuator.
5. Install new air line as shown on Figure 1.
6. Re-enable the emergency extension system per the aircraft maintenance manual.
7. Perform functional tests of both normal and emergency landing gear system, per aircraft maintenance manual.
8. Remove aircraft from jacks and make proper log book entry of accomplishment.

INSTALL EMERGENCY GEAR EXTENSION AIR LINE TO CLEAR BOTH LEFT AND RIGHT BRAKE CYLINDERS (EFF. FOR AIRCRAFT S/N'S 31T-1166001 THRU 31T-8166062)
