# SERVICE BULLETIN

## WHEEL ASSEMBLY 40-40B – INNER BEARING CUP - INSPECT/REPLACE

**EFFECTIVITY:** Parker Hannifin 10-inch Main Wheel Assembly Model Number 40-40B, wheels manufactured in December, 2000, identified with Mfg. Date Code "12/00".

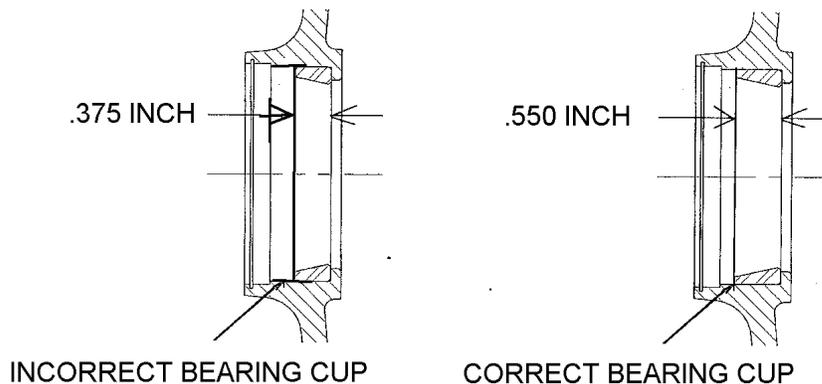
40-40B Wheels with Mfg. Date Code "12/00" (Manufactured in December, 2000) may be equipped with the wrong Inner Bearing Cup, and must be removed from the aircraft and inspected to determine if the correct Inner Bearing Cup is installed. The bearing cup width should be .550 inch. If the incorrect bearing cup is installed, cup width will measure at .375 inch. Tear down of the wheel assembly is not required to perform this inspection. This measurement can be made by removing the Inner Bearing Cone. Refer to figure below for inspection criteria.

4. If inspection indicates that the incorrect Inner Bearing Cup is installed, remove the existing Inner Wheel Half Assembly and Inner Bearing Cone, and replace with new Inner Wheel Half Assembly and Inner Bearing Cone as listed in MATERIALS Section of this Service Bulletin. Maintenance to be performed per Cleveland Wheel & Brake Maintenance Manual (AWBCMM0001).
