Parker Hannifin Corporation

SERVICE BULLETIN

MAIN BRAKE ASSEMBLY 30-204A – TORQUE RING – INSPECT/REPLACE

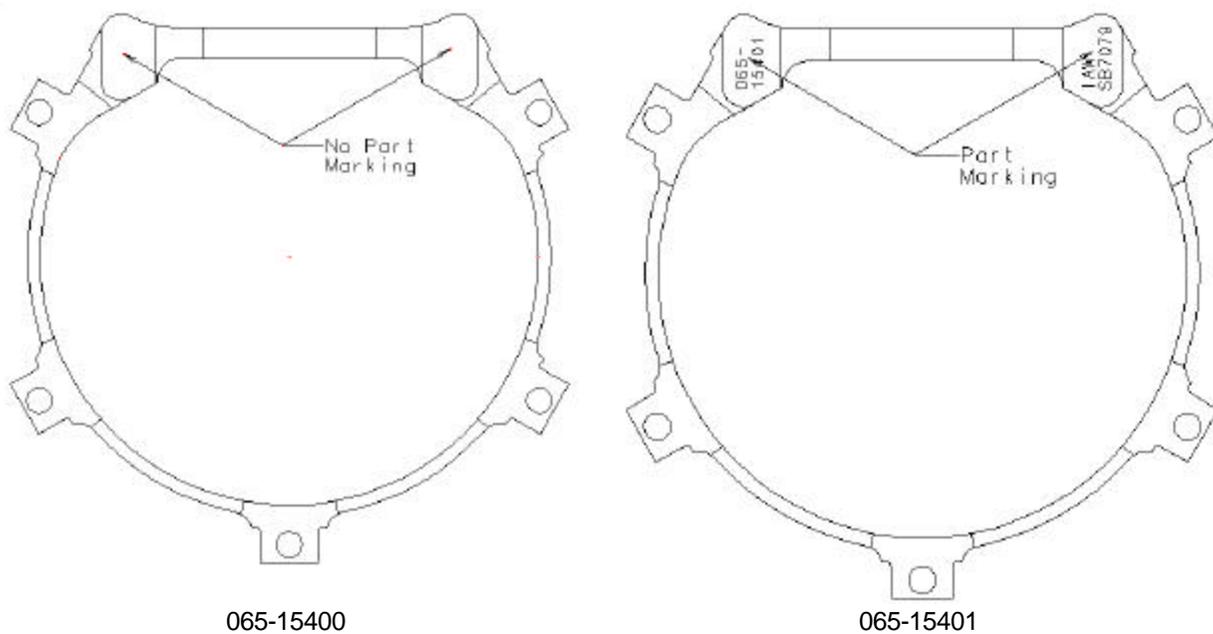
Figure 1

- REASON:** Raytheon Aircraft Co. (RAC) Service Bulletin 32-3576 introduced main landing gear (MLG) socket, RAC P/N 129-810022-0003. RAC P/N 129-810022-0003 interferes with Parker Hannifin P/N 065-15400. P/N 065-15400 is a component of Parker Hannifin Brake Assembly 30-204A that was used on Brake serial numbers 101 thru 872. Beginning with S/N 873, 30-204A Brake Assemblies are assembled with P/N 065-15401 when new.

- 1) At the time of installation of MLG socket RAC P/N 129-810022-0003, or at next brake overhaul whichever occurs first, inspect aircraft records to determine if Main Wheel and Brake Assembly Conversion Kit P/Ns 199-184, 199-220, or 199-220A are installed.
- 2) Aircraft that have been identified as not being equipped with Conversion Kit P/Ns 199-184, 199-220, or 199-220A may be returned to service.
- 3) For aircraft that are identified as being equipped with the 199-184, 199-220, or 199-220A Wheel and Brake Kit, inspect the Brake Assembly to determine which torque ring part number is installed (ref. Figure 1).

- 4) If inspection indicates that the 065-15400 torque ring is installed, contact Parker Hannifin, Aircraft Wheel & Brake Division Service Center (Ph. 1-440-937-1272) for instructions to obtain replacement 065-15401 torque rings.
- 5) Consult CM 30-204A for disassembly and assembly instructions as required. Re-assemble with P/N 065-15401 in lieu of 065-15400. Note that P/N 065-15401 is marked to indicate that the assembly has been reworked in accordance with (IAW) Service Bulletin SB7079.
- 6) Aircraft with 30-204A main brake assemblies, reworked to use Parker P/N 065-15401 torque rings, may be returned to service.
