SERVICE BULLETIN

UPGRADE OF 40-97E WHEEL ASSEMBLY TO 40-97F CONFIGURATION

- EFFECTIVITY:** Parker P/N 40-97E Wheel Assemblies equipped with Grease Seal Felt P/N 154-00300 and Grease Seal Rings P/N 153-00400 on Inboard Wheel Half.

- APPLICABILITY:** 40-97E Main Wheel Assemblies for use on Socata Model TB9, TB10 & TB200 aircraft equipped with Trailing Arm Landing Gear.
- REASON:** Product Upgrade - To allow reconfiguration of the P/N 40-97E Wheel Assembly currently using a diameter 1.625 in. I.D. Grease Seal Felt on the Inboard Wheel Half to P/N 40-97F Wheel Assembly which will use a diameter 1.875 in. I.D. Grease Seal Felt on the Inboard Wheel Half. This upgrade will permit proper interface of the Wheel Assembly to Trailing Arm Gear designed for use on TB9, TB10 & TB200 aircraft.

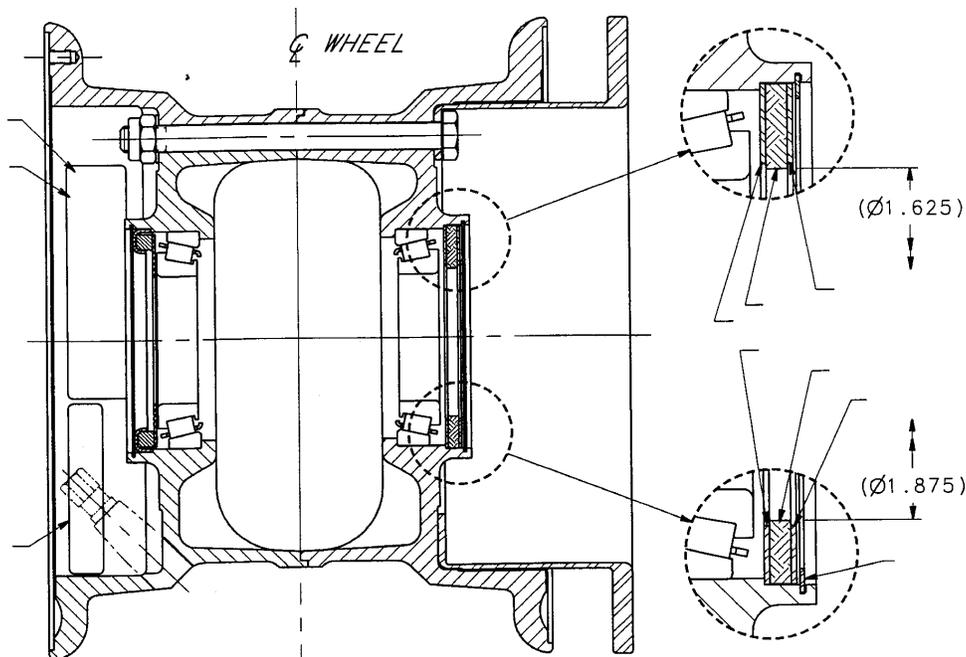
Figure 1 - Converting 40-97E Wheel Assembly to 40-97F Configuration

1. The following components must be removed from the existing P/N 40-97E Wheel Assembly and discarded: (See Figure 1 for location of components)

2. Prior to installing new Grease Seal Rings and Grease Seal Felt on Inboard Wheel Hub, lightly saturate the Grease Seal Felt, P/N 154-01600 with SAE10 oil.
3. Install Grease Seal Rings P/N 153-01600 and Grease Seal Felt P/N 154-01600 on Inboard Wheel Hub as shown in Figure 1 and secure with Retaining Ring P/N 155-00100.
4. Install new nameplate P/N 166-19700 on Outboard Wheel Half as shown in Figure 1. Note: The manufacturing date code for all replacement nameplates will be coded with the current date that the nameplate is printed. Example: A nameplate that is printed in April of 1997 will be identified as Mfg. 04R97 (An "R" between the month and year indicates that this is a replacement nameplate).
5. Install P/N 166-20000 "Warning" Nameplate adjacent to the valve.
